LDEF — 69 Months in Space

First Post-Retrieval Symposium

Title: LDEF - 69 Months in Space: First Post-Retrieval Symposium, Part 2

Corporate Author Or Publisher: NASA Langley Research Center, Hampton, VA 23665-5225 Report Number: L-17042

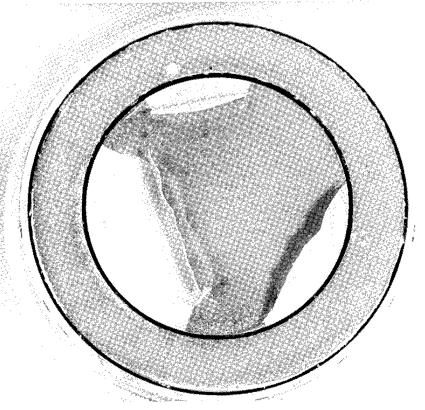
Figure 9 - Post-flight Condition of RTV670 over A276

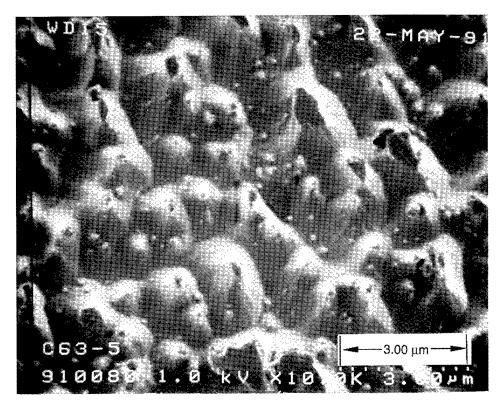
SEM of Exposed Teflon Surface Sample #S-1 Figure 4

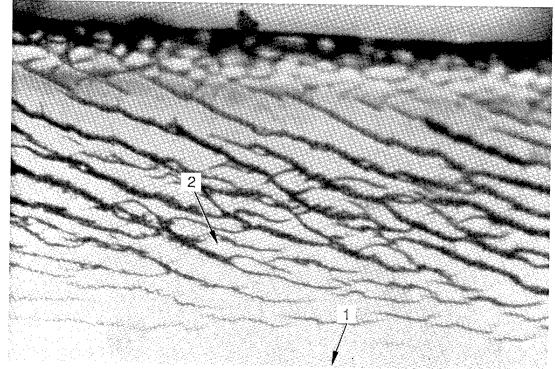
Figure 6

Cracking of Silver/Inconel Layer - Overlap Region

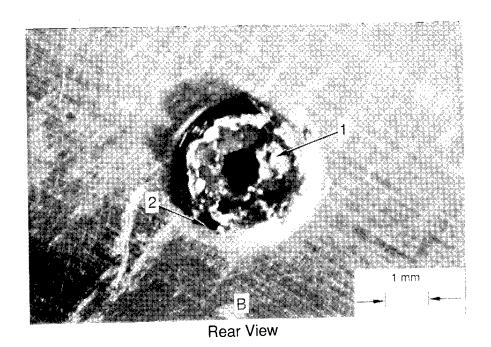
Impact Penetration of Front Panel (Panel: 6061AL; 0.063 MIL Thickness)

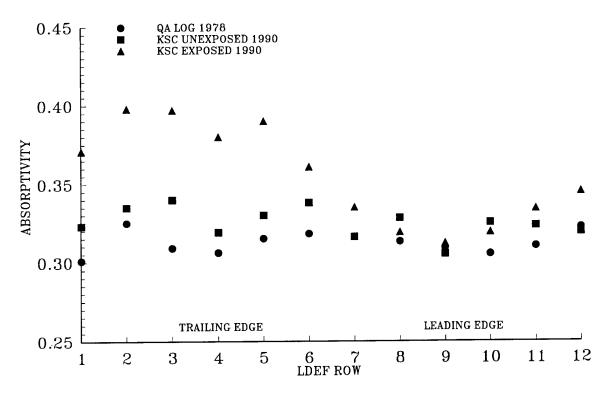
Presented in Figure 3 are the average row absorptivities versus LDEF row location for the QA log, unexposed, and exposed surface measurements. The figure shows almost no change in absorptivity on the leading edge row 9 to approximately a 24% increase on the trailing edge row 3. Figure 4 shows the average row emissivity for each category of measurement made versus LDEF row location. The average normal emissivity for exposed surfaces was 0.15 ± 0.03 which was the same as the QA log average of 0.15 ± 0.03 . One consistent trend observed while surveying the structure was the 20.0% increase in unexposed surface average emissivity (0.18 \pm 0.04) over the QA average emissivity values.

Figure 3. LDEF Structure: Average Absorptivity vs Row Location

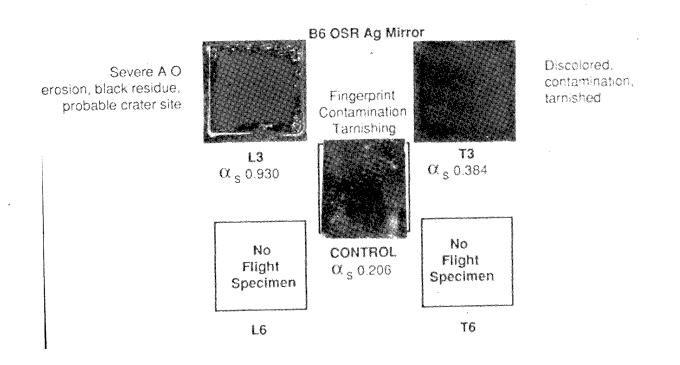
C2 FEP/Ag/Inconel 5 mil

Aging, pinholes in metallic coating

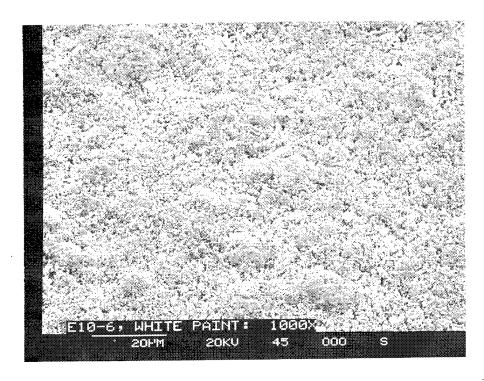
Figure 4. SEM (1000X) From A276 White Thermal Control Paint Located On Tray Clamp E10-6. Roughened surface is typical of leading edge white paint specimens, showing the loss of polyurethane resin from the surface.

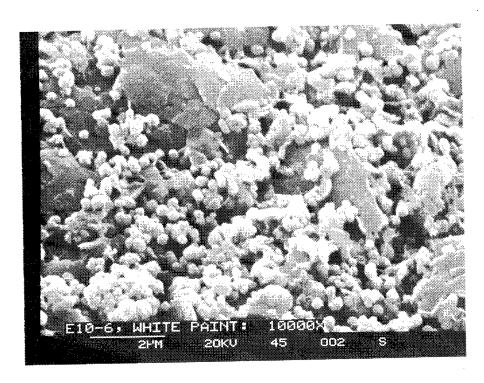
Figure 5. SEM (10,000X) From A276 White Thermal Control Paint Located On Tray Clamp E10-6. Small spherical particles are titania pigment, large plate-like crystals are magnesium silicate (talc).

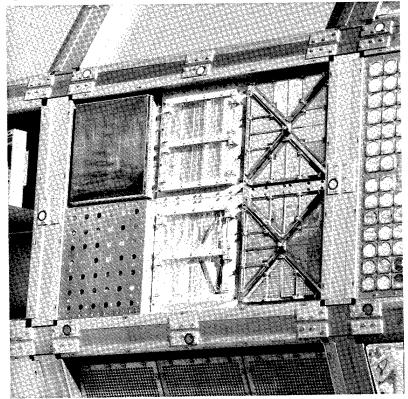
Figure 2. Post-flight photograph of IBEX location in tray E-6.

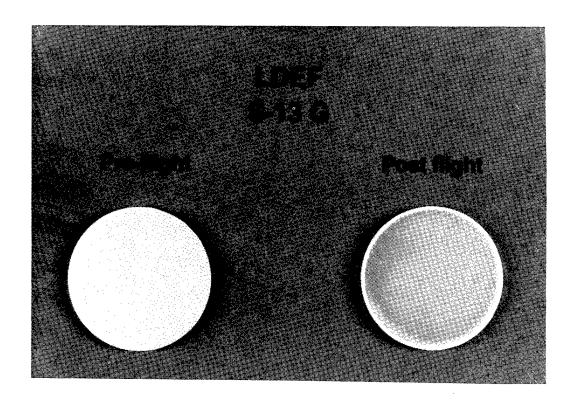
Figure 7. Photograph of pre- and post-flight S-13G.

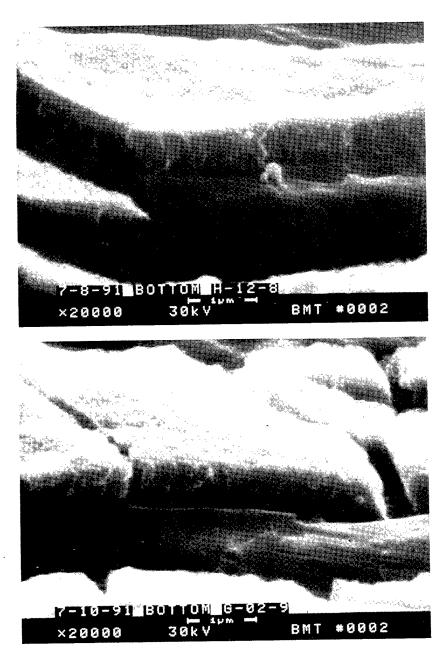
SEM analysis was employed to measure the anodize coating thickness on the tray clamps. Small specimens cut from the clamps were fractured and photomicrographs were obtained of the fracture surfaces from both the front and back of the clamps. The coating thicknesses were then measured directly from the photomicrographs. The back side of each clamp acted as a control and the data was evaluated to determine if space exposure had any effect on the coating thickness. Typical photomicrographs showing the anodize coating are presented in Figure 4.

FIGURE 4. Typical SEM photomicrographs showing anodize coating thickness

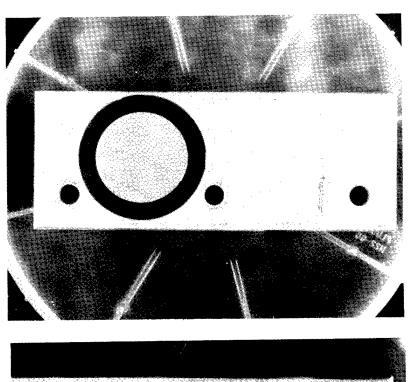
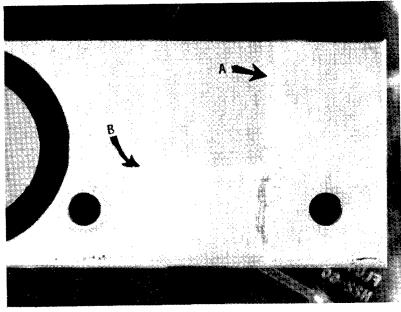
FIGURE 6 Photo macrographs of tray clamp E02-6 with arrows indicating boundaries between exposed regions and those protected by (A) the copper ground strap and (B) the aluminum shim.

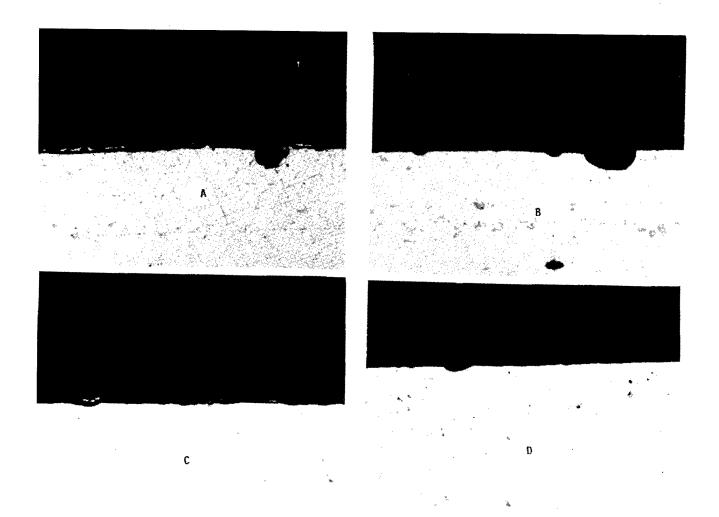
FIGURE 7 Optical photomicrographs at 1000X depicting (A) protected and (B) exposed regions from the surface of leading edge clamp E10-6 and from (C) protected and (D) exposed areas from trailing edge clamp E02-6.

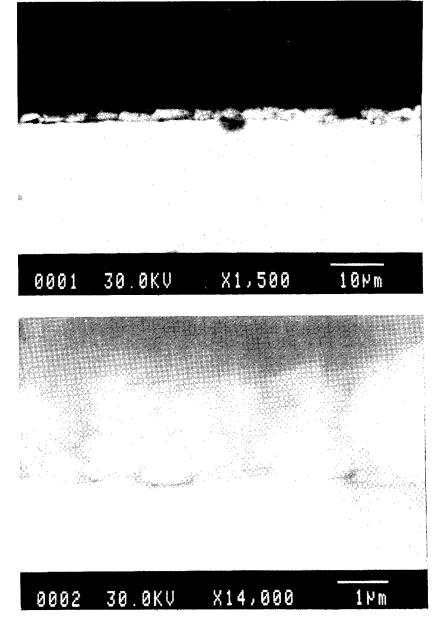
FIGURE 8 Higher magnification scanning electron photomicrographs depicting the observed surface layer on the protected surfaces of tray clamp E10-6.

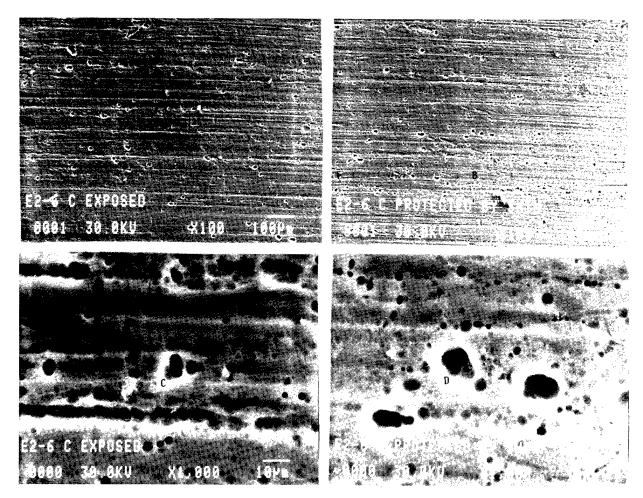
FIGURE 9. SEM photomicrographs depicting surface porosity on (A) exposed and (B) protected at 100X and (C) exposed and (D) protected at 1000X for trailing edge clamp E02-6.

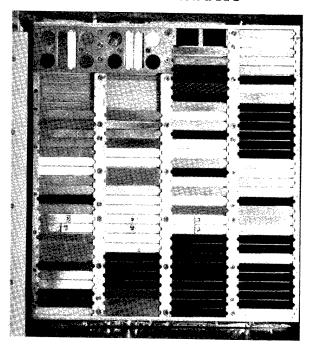
Several observations were made from a visual inspection and by comparing preflight and post-flight photographs of the sample cassette assemblies (fig. 1). First, it was noted that all of the composites survived in excellent physical condition. Surface roughening due to atomic oxygen erosion for uncoated organic matrix composites mounted on the exposed leading edge was the only significant visible damage. However, the erosion depth appeared to be shallow relative to the overall thickness of the affected composites. Contamination was evident on both the leading and trailing edges. For example, a large contaminated area is apparent on seven samples in the lower left corner of the leading edge cassette in the postflight photograph of figure 1. This contamination was from another experiment or from the LDEF structure. However, there were also rainbow outgassing stains on trailing edge samples adjacent to elastomeric samples, which were from a different subexperiment of M0003 but were mounted on the Advanced Composites Experiment cassette. The most dramatic change was a yellowing or browning of many of the thermal control coatings. This was only observed for the exposed samples on the trailing edge (fig. 1). The exposed leading edge paints and those on the Deck B samples remained white. The yellowed samples were McDonnell Douglas samples having a ZnO silicone coating and the brown samples included General Dynamics samples with ZnO and TiO2 coatings and McDonnell Douglas samples with a leafing aluminum coating. Further discussion on the browning of thermal control coatings flown on the M0003 trays is given by Meshishnek and Gyetvay (refs. 1 & 2).

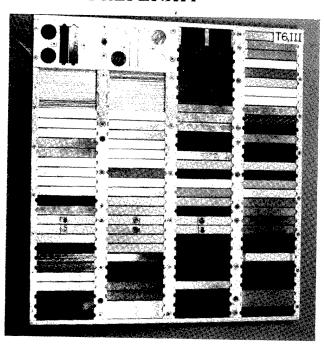
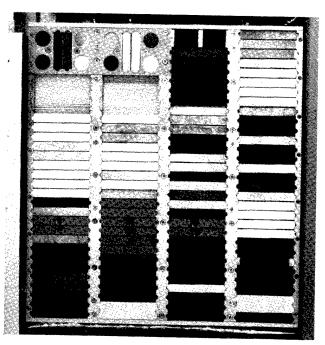
Figure 1. Preflight and Post-Flight Photographs of Exposed Side of Leading Edge and Trailing Edge Sample Cassettes.

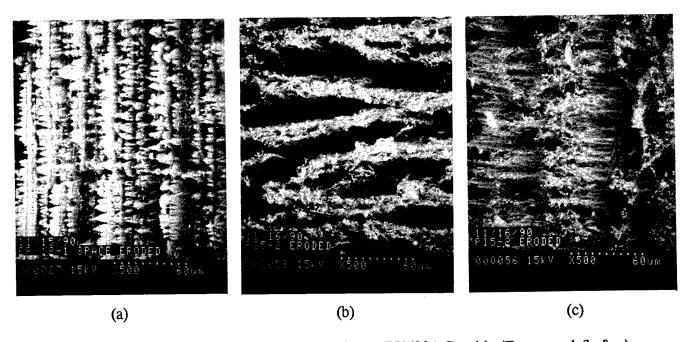
Figure 3. Scanning Electron Micrographs of (a) P75S/934 Graphite/Epoxy and (b & c) T300/V378A Graphite/Bismalimide Exposed to Atomic Oxygen on the Leading Edge.

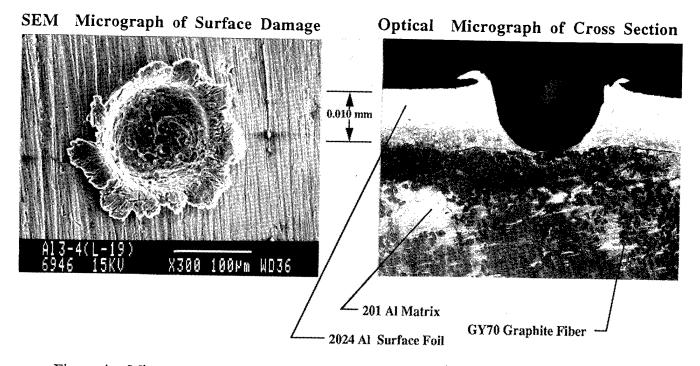
Figure 4. Micrometeoroid Damage to a GY70/201/2024 Graphite/Aluminum Composite.

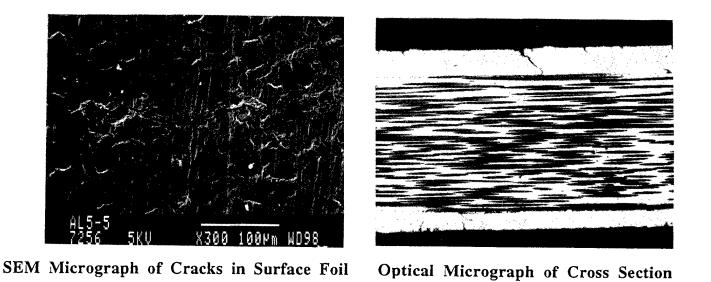
Figure 5. Surface Foil Cracking of a GY70/201/2024 Graphite/Aluminum Composite Resulting From Thermal Fatigue of a Brittle Contaminated Surface.

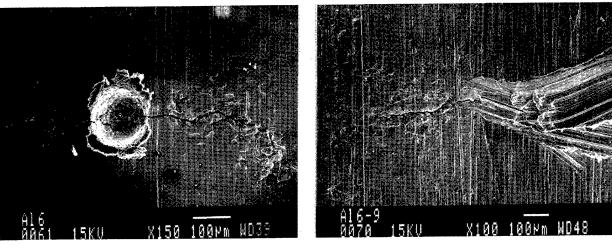
Figure 6. Isolated Fatigue Cracks That Initiated at Stress Risers on the Surface of GY70/201/2024 Graphite/Aluminum Composites.

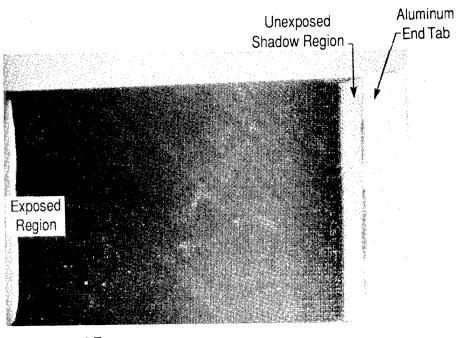
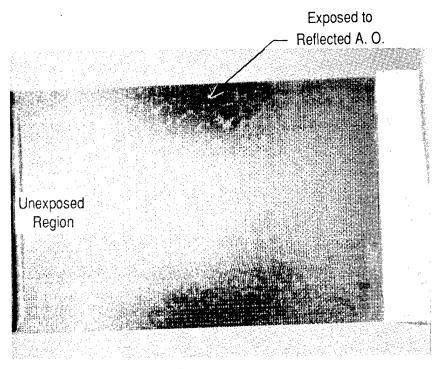
Fig. 9 Photographs of Top (a) and Bottom (b) Faces of Graphite/Epoxy LDEF Sample

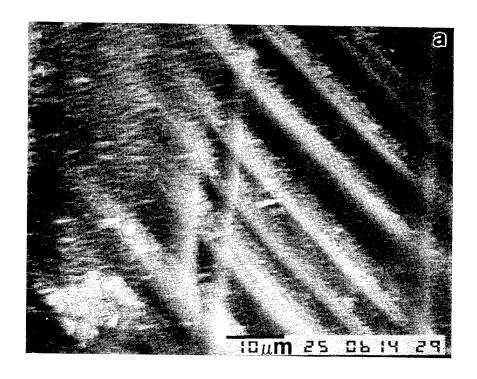
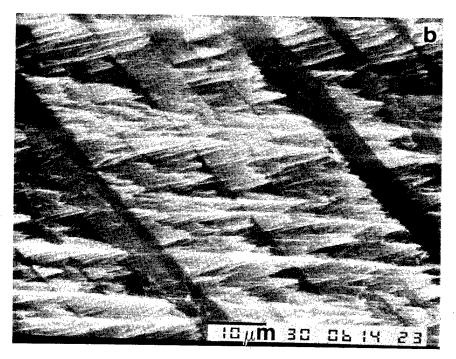
Fig. 10 SEM Photographs of Graphite/Epoxy **LDEF** Sample

- a) 3 mm from end fixture (note boundary between unexposed/exposed regions)
- **b**) 6 mm from end fixture-exposed region

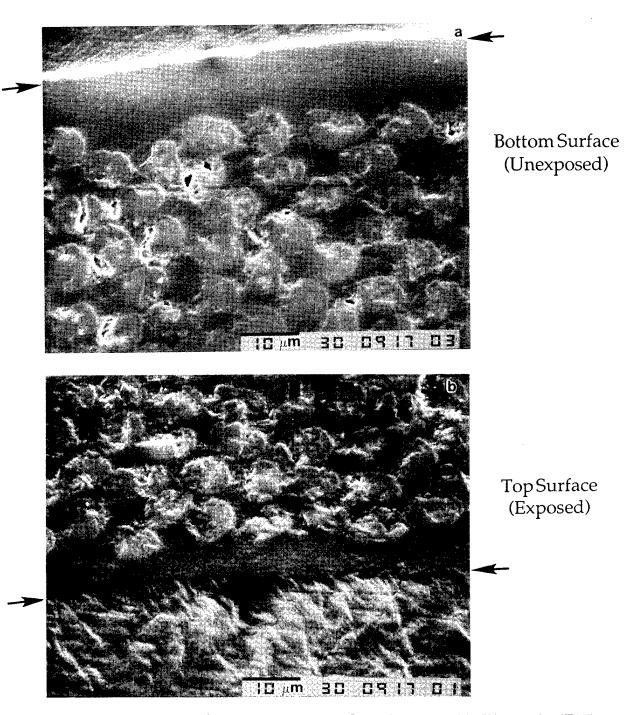
Fig. 11 Cross -Sectional SEM Micrographs of Graphite/Epoxy LDEF sample (F15) (6 mm from end fixture in shadow region)
(Arrows indicate sample interface with potting compound)

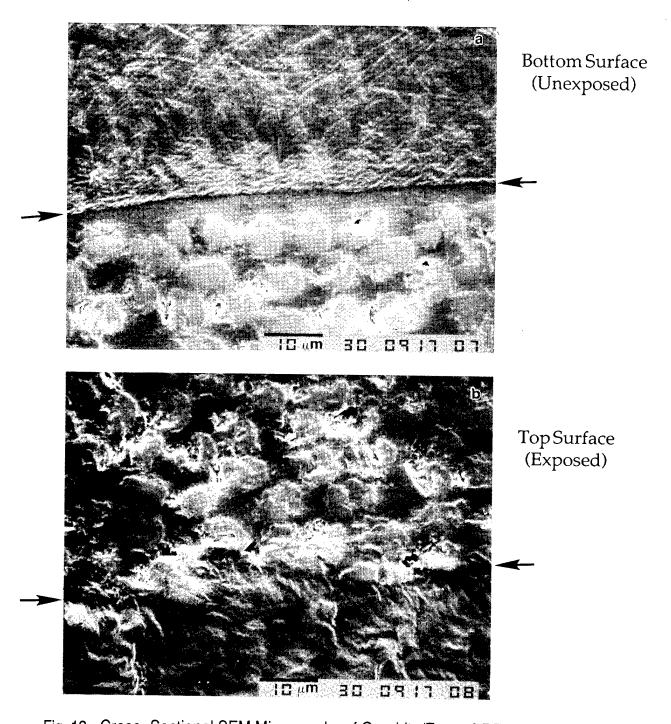
Fig. 12 Cross -Sectional SEM Micrographs of Graphite/Epoxy LDEF sample (F15) (7 mm from end fixture, out of shadow region) (Arrows indicate sample interface with potting compound)

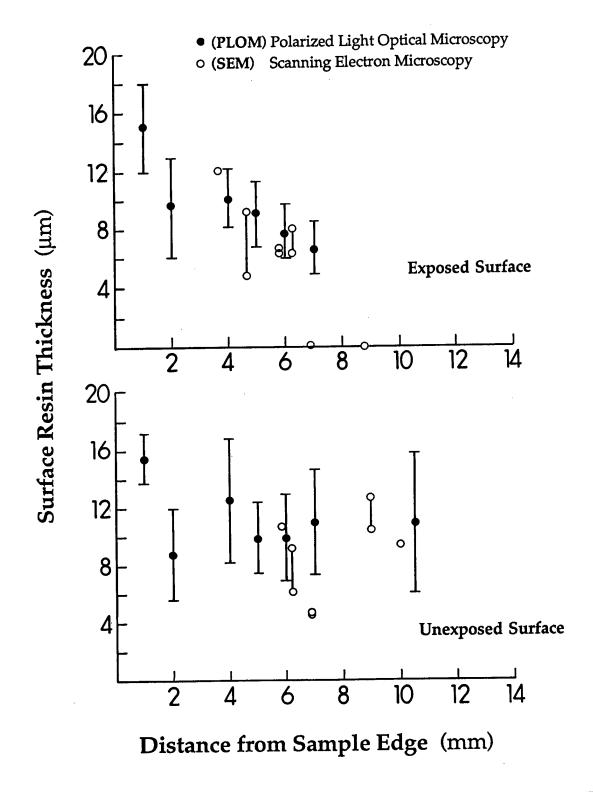
Fig. 13 Effect of Atomic Oxygen Erosion on Graphite/Epoxy LDEF Sample (F15)

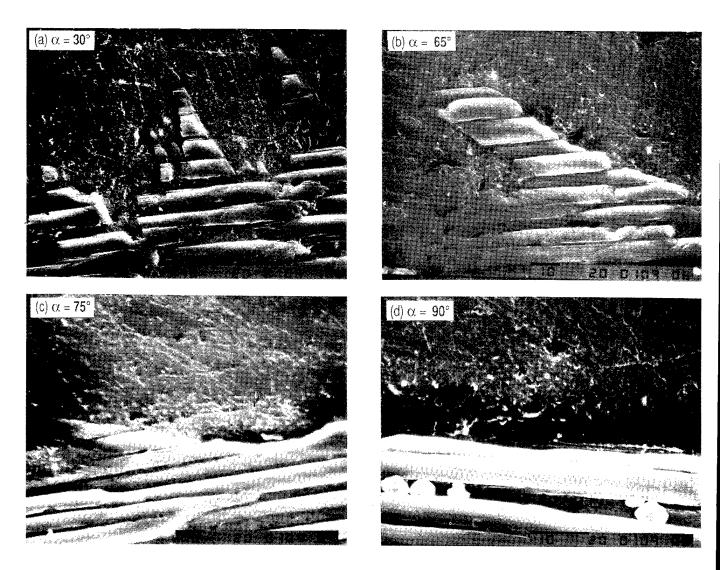
Fig. 14 Cross-Sectional SEM Photographs of Erosion Profile at Different Angular Positions (α) around Graphite/Epoxy Composite Tube

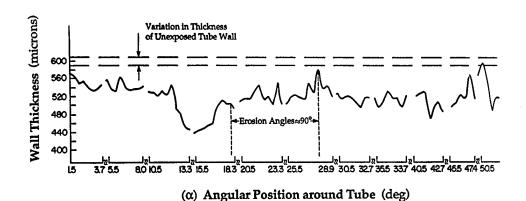
Fig. 15 Erosion Profile of Graphite/Epoxy Circular Tube due to Atomic Oxygen

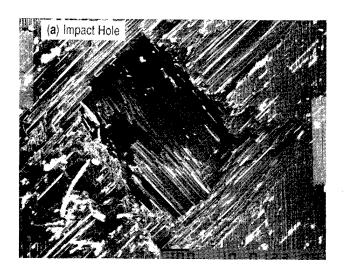
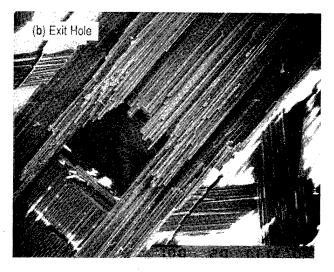
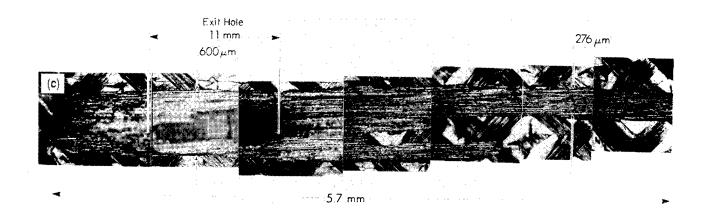
The UTIAS experiment suffered 74 impacts with craters <0.5 mm in diameter, and 10 impacts at \geq 0.5 mm in size, randomly distributed over the surface area as shown in fig. 17. Figure 18 shows SEM photographs of the impact (a) and exit holes (b) observed on a 4 ply graphite/epoxy laminate of $(\pm45)_S$ construction. Of particular concern is the extensive spallation damage that occurred on the rear face (c) in which a rather large (5.7 mm) section of laminate was removed from the structure.

Fig. 18 View of Exit Damage from Micrometeoroid/Debris Impact on Graphite/Epoxy Laminate (5208/T300; (\pm 45°) $_{\rm s}$)

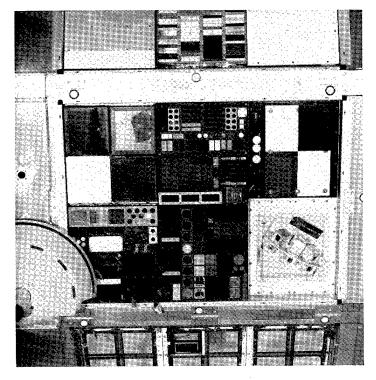
Figure 8. On-orbit photograph of D9 tray, leading edge. Note the debris above the surface from AO-deteriorated materials on the tray

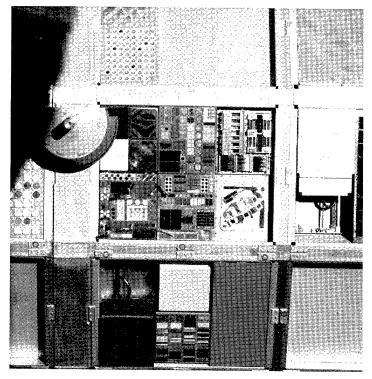
Figure 9. On-orbit photograph of D3 and D4 trailing edge trays. Most noticeable effects are contamination-staining and darkening of white paint coatings

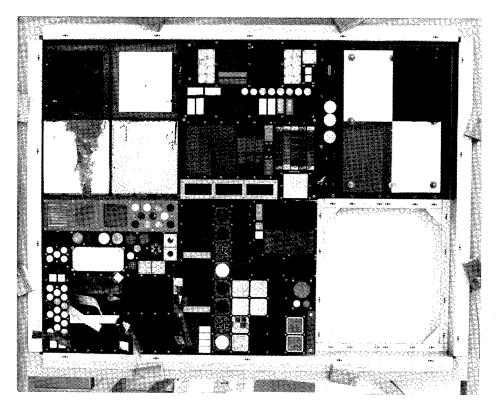
Figure 10. D9 tray postflight, before M0003 deintegration, in tray-holding fixture

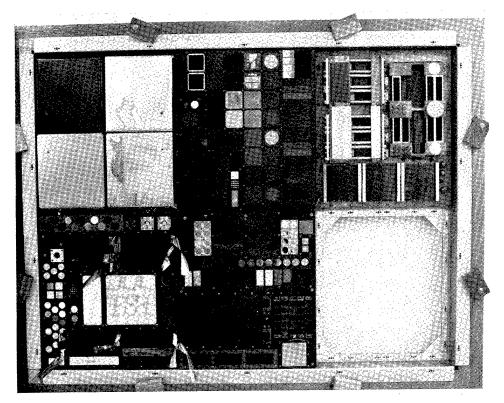
Figure 11. D3 tray postflight, before M0003 deintegration, in tray-holding fixture

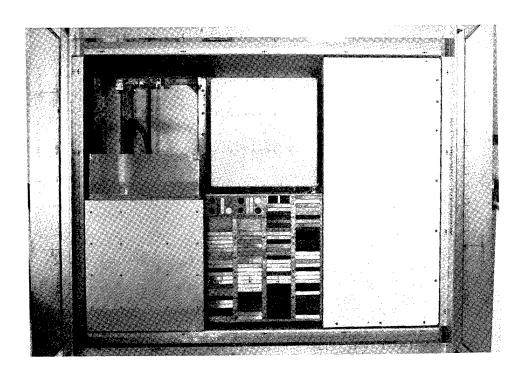
Figure 12. D8 tray postflight, before M0003 deintegration, in tray-holding fixture

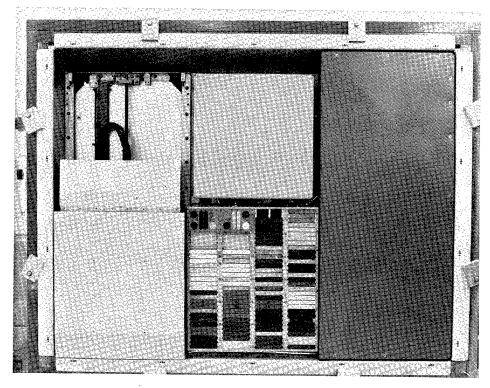
Figure 13. D4 tray postflight, before M0003 deintegration, in tray-holding fixture

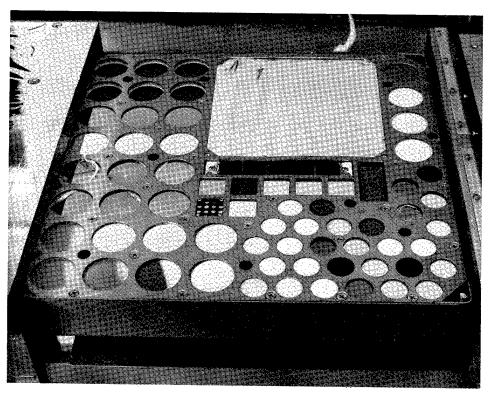
Figure 14. D8 (LE) canister in open position, postflight. The two rows to the left (top to bottom in photo) were exposed for 9 and 19 weeks, respectively. The remaining test articles were exposed for 40 weeks

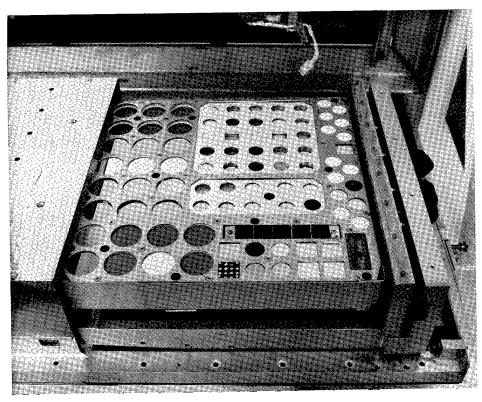
Figure 15. D4 (TE) canister in open position, postflight. Exposure was identical to that for D8 canister. Many, but not all test articles are duplicates of those flown on LE canister

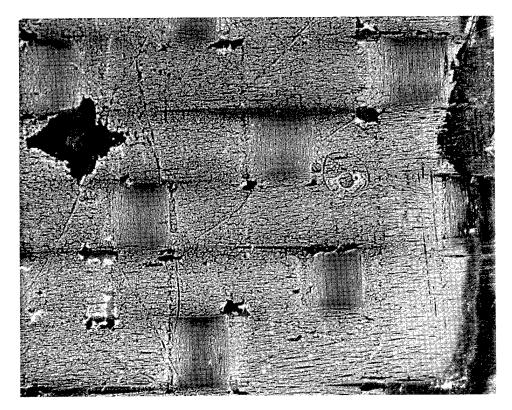
Five different types of solar cell strings (Si and GaAs cells of conventional and high efficiency design) were flown on the leading and trailing edge of LDEF. These samples were instrumented and measurements were recorded for 14 months of exposure. The data system measured the voltage across a $0.05~\Omega$ short circuit and the data reduction routine calculated the output current. Examination of the cell strings after retrieval showed the cover glasses over the cells were superficially contaminated. The silver welds on the interconnects appeared intact, but localized delamination of the cover glass was apparent on some cells around the welds. Since the current measurements did not show any significant change in the performance of these cells, this degradation probably occurred after the data recording period. The damage is illustrated in Figure 24.

Figure 24. Localized delamination of cover glass near silver weld on LE solar cell

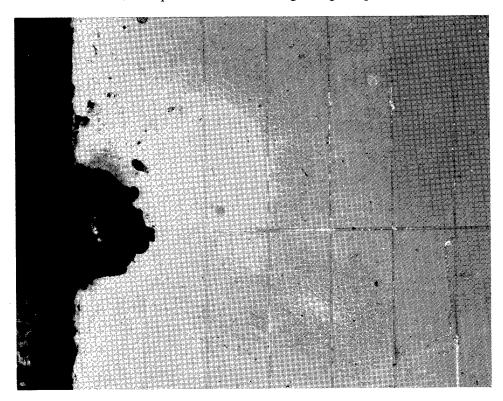
Hypervelocity impacts created craters surrounded by localized damage on many optical specimens. The greatest expanse of damage occurring due to impact was a 1-cm circle of blistered coating surrounding a 1-mm diameter crater on a mirror specimen, shown in Figure 26. Sensors or windows which are exposed to solar UV, atomic oxygen or micrometeoroids can experience significant optical performance degradation if the coatings are disrupted.

Figure 26. Blistered coating damage surrounding 1-mm dia. impact crater in LE $ThF_4/Ag/Mo$ mirror test article

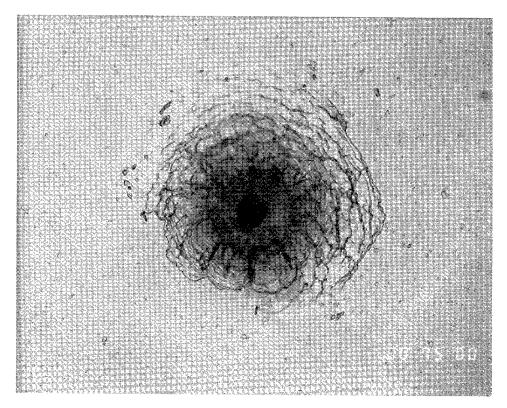
Figure 25. Typical micrometeoroid/debris damage in a solar cell cover glass

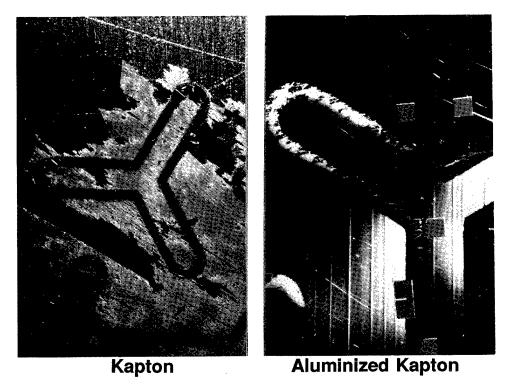
Figure 27. Atomic oxygen erosion of aluminized Kapton radar camouflage material.

This produced significant debris which became scattered over many LDEF trays

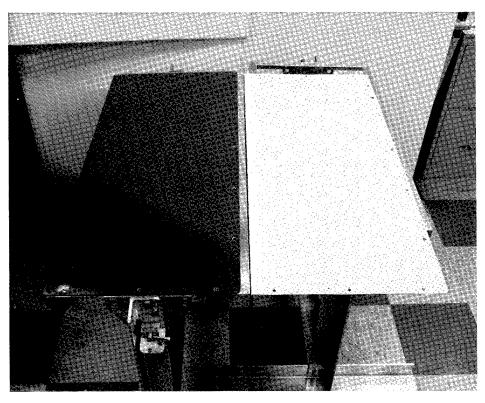
Chemglaze A276 was used on the EPDS sunshield and is composed of TiO2 pigment in a polyurethane binder. Table III summarizes the solar absorptance (α_s) values measured for both leading edge and trailing edge specimens compared to control specimens. Figure 28 shows the dramatic difference in response of the sunshields to the LDEF exposure from LE to TE. Close examination of the paint surface indicated that the TE specimen was glossy and specular while the LE was roughened, chalky, and full of numerous impact craters. These impact craters were surrounded by areas of blistered and peeling AO-eroded surface, pointing to preferential erosion of the organic polyurethane binder, leaving unsupported TiO2 pigment as the surface. Figure 29 presents scanning electron microscope photos of the TE and LE specimens that show loss of binder from the LE specimen. Elemental analysis x-ray analysis indicates substantial loss of carbon signal from the surface of the LE specimen. As a final proof of concept, a specimen of LE EPDS sunshield paint was cut that contained a recessed bolt hole. The paint around the bolt hole had a glossy appearance where it was protected from AO on orbit, an indication that no erosion of the binder had occurred in that area. Figure 30 illustrates the response of the specimen to 500 hours of UV irradiation in a laboratory test. The darkening of the specimen only in the bolt-protected area where polyurethane binder was still present graphically reveals that the degradation is due to UV damage to the binder. The major whitening mechanism must be AO erosion of this damaged layer.

Figure 28. Chemglaze A276-painted sunshields flown on D4 (TE) on left and D8 (LE) on right

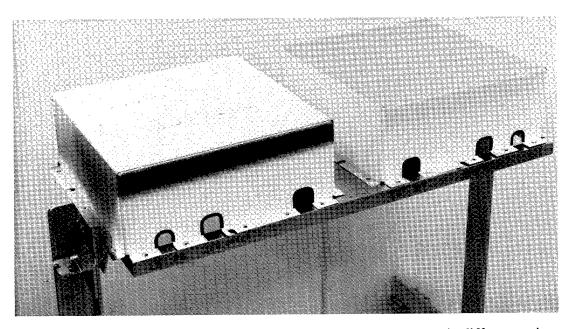
Figure 32. Signal conditioning unit (SCU) covers showing dramatic differences in damage from LE to TE. Note marked outgassing patterns on LE cover

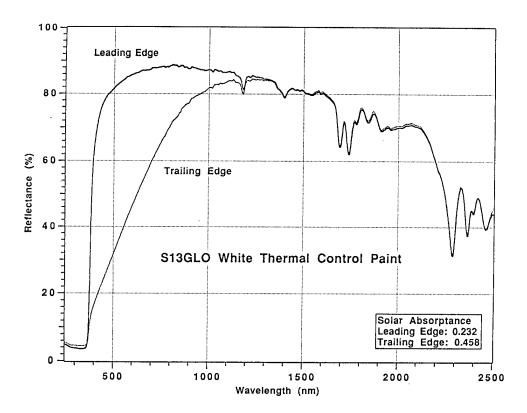
Figure 33. Reflectance curves for S13GLO

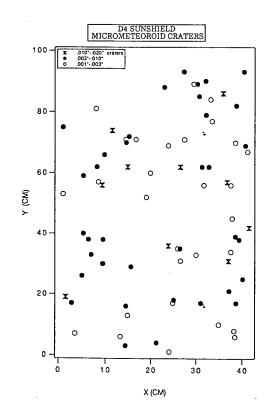
Figure 34. Micrometeroid/debris impacts on TE EPDS sunshield

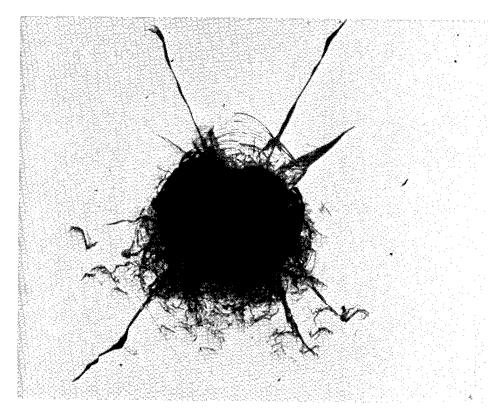
Figure 38. Hypervelocity impact on embrittled surface of vacuum-distilled black RTV 602

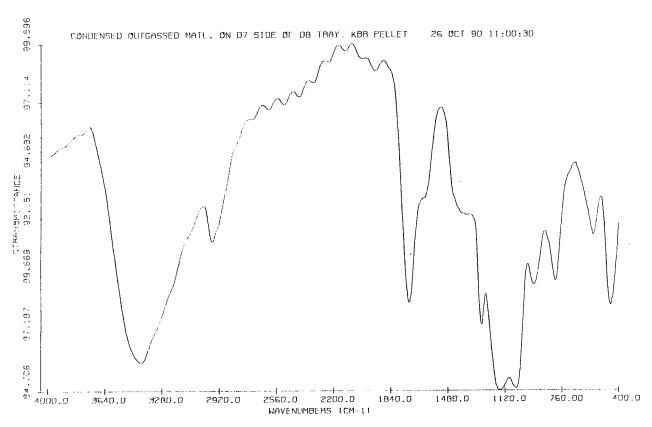
Particulate contamination on individual test articles could be identified as originating from deteriorated nearby materials on M0003 and other LDEF trays. Debris found on test articles flown in the canisters, particularly fibrous debris (Figure 40), may have come from the shuttle payload bay.

Figure 40. Debris contamination adhered to surface of 1.5 in. dia. silicone-based white paint test article exposed for 40 weeks in the TE (D8) canister

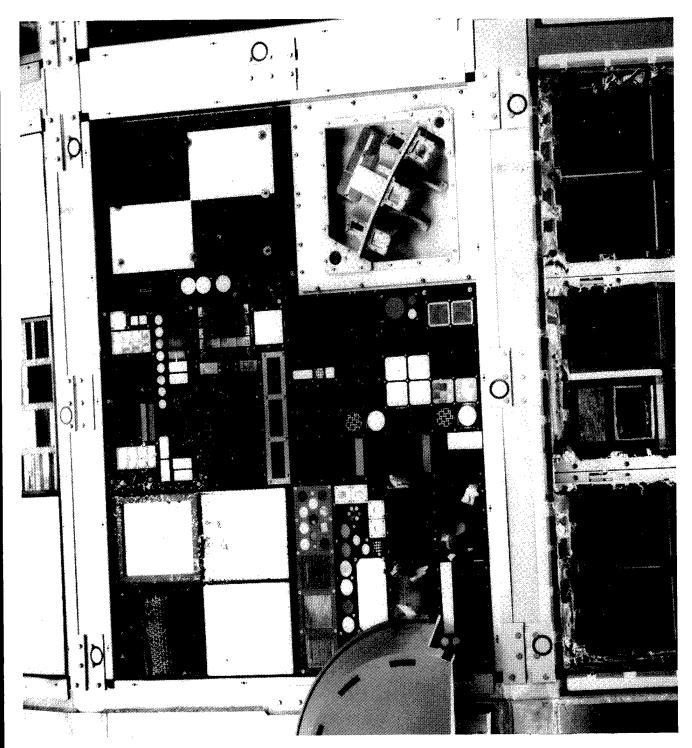
Figure 1 shows a photo of tray D-9 taken on orbit. The failure of the hardware in one module and subsequent distribution of aluminum pieces onto adjacent hardware, including a number of our composite specimens, clearly is shown. It also shows that our solar cells had become detached during flight. The likely cause was failure of the adhesive, but the mechanism is not known. The effects of the aluminum flakes are to block the surface underneath from atomic oxygen and solar radiation, limiting recession of these materials. Since the absorptance/emissivity ratio for aluminum can easily range from 2.5 to 5, the potential exists for localized heating of small areas. However, the bulk temperature is probably little effected because the individual aluminum flakes are relatively small. The exposure time of the debris on our hardware is unknown. Figure 2 shows tray D-9 as it appeared subsequent to removal from LDEF in the SAEF-II building at KSC. The aluminum debris visible in the photo of figure 1 is not present in figure 2. This material was redistributed during the retrieval or re-entry operations.

FIGURE 1 On-Orbit Photograph of Tray D-9 From The Leading Edge of LDEF

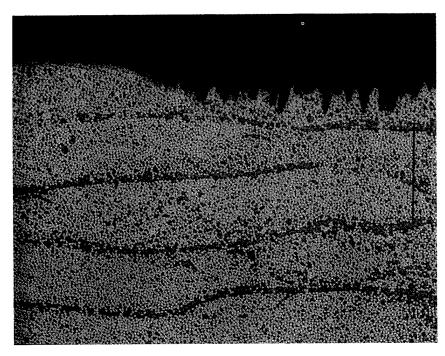
FIGURE IX. - CROSS SECTION OF POST FLIGHT LEADING EDGE EXPOSED 934 EPOXY/T300 GRAPHITE (100X)

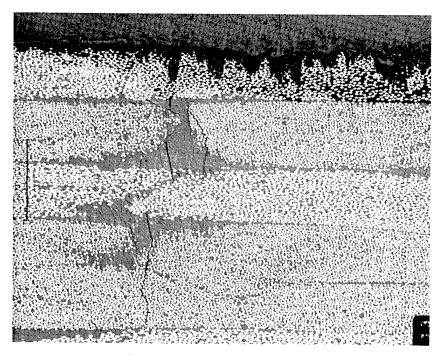
FIGURE XI. - CROSS SECTION OF POST FLIGHT LEADING EDGE EXPOSED P1700 POLYSULFONE/T300 GRAPHITE (80X)

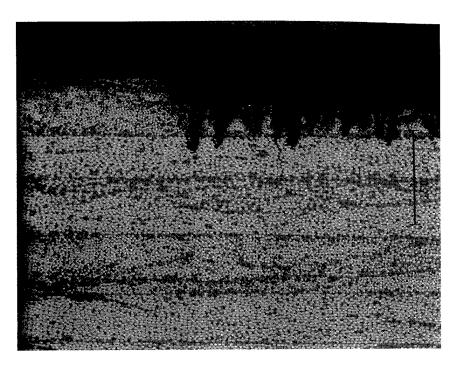
The PMR15-polyimide/C6000 graphite flexure specimens showed a decrease in moduli compared to preflight values. The most severe decrease is observed for the leading edge specimens which also displayed the lowest strength values.

FIGURE XIII. - CROSS SECTION OF POST FLIGHT LEADING EDGE EXPOSED PMR-15 POLYIMIDE/C6000 GRAPHITE (100X)

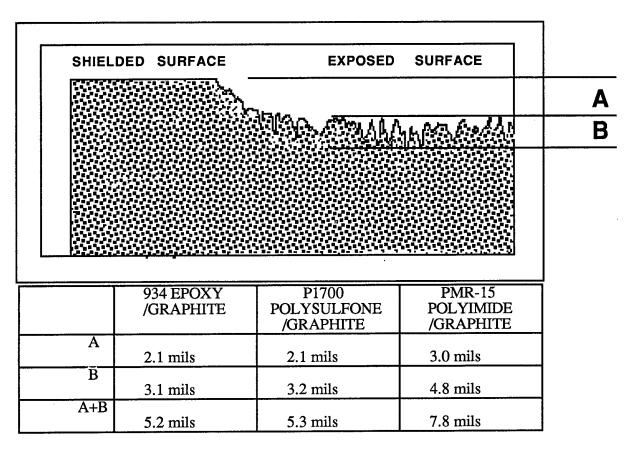
FIGURE XVI. - RECESSION OF LEADING EDGE COMPOSITE SURFACES

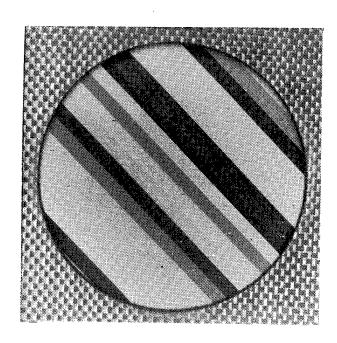
Figure 6. Uncoated 5208/T300 epoxy/graphite specimen with center area showing effects of 5.8 years of flight exposure.

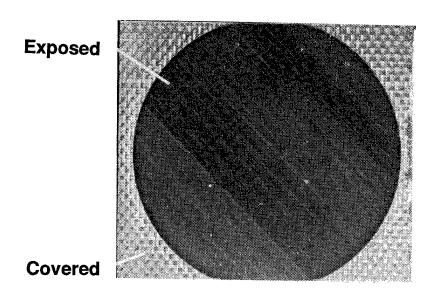
Figure 9. Effects of 5.8 years of LDEF flight exposure on uncoated P1700/C6000 polysulfone/graphite composites.

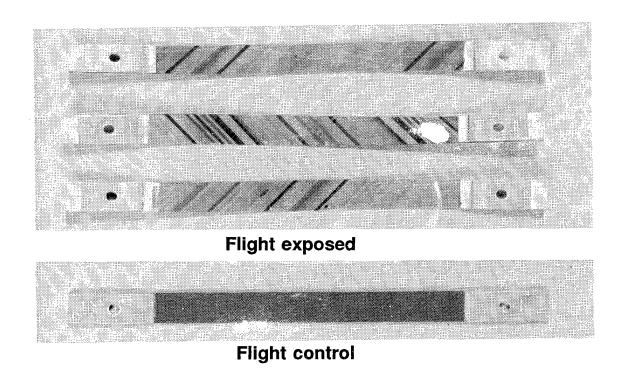
Figure 12 illustrates the erosion of the 5208/T300 graphite/epoxy flight exposed tensile specimens when compared to the virtually unaffected flight control specimen. The flight exposed specimens have the stripes typical to most of the specimens and the surface erosion caused these specimens to bow from unbalanced stress.

Figure 12. Epoxy/graphite composite 5208/T300 tensile specimens.

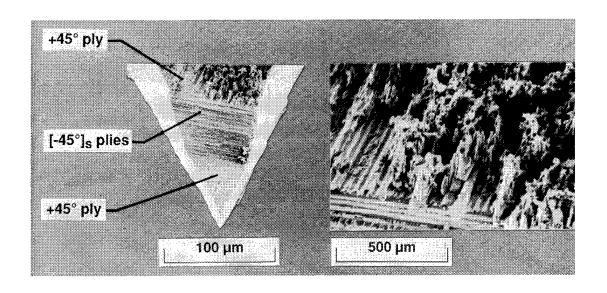
Figure 16. SEM of 5208/T300 epoxy/graphite $[\pm 45]_S$ composite after 5.8 years exposure.

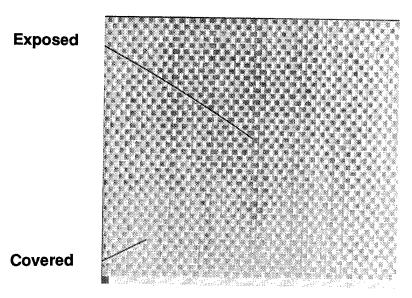
Coating: 600A Si0₂/1000A Ni/Composite

Figure 17. Effects of 5.8 years of LDEF exposure on coated 934/T300 epoxy/graphite composite.

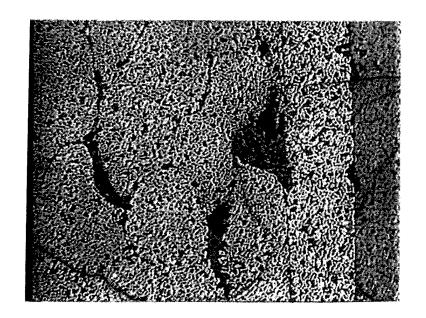
Photograph 6

Surface cracks (Radial type)

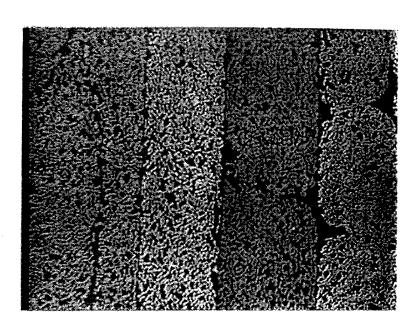
Photograph 8

Central cracks

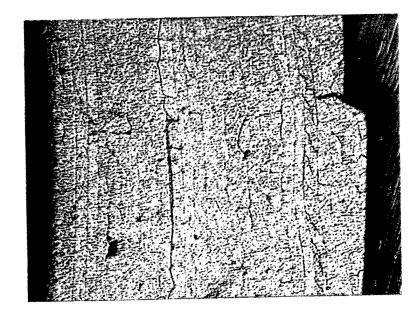
Photograph 10

General view (Sun exposed face)

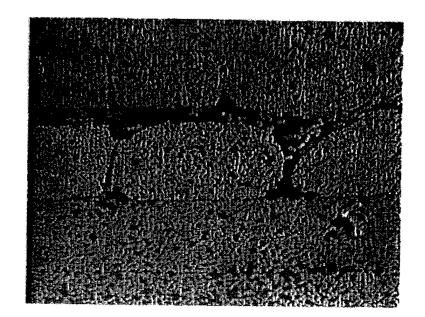
Photograph 11

Heap of resin

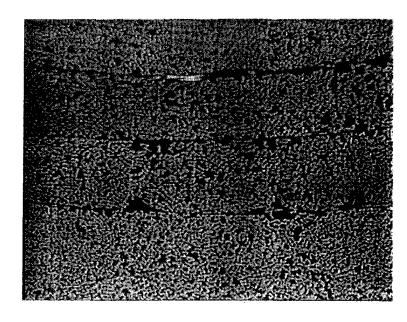
Photograph 12

Concentrated cracks

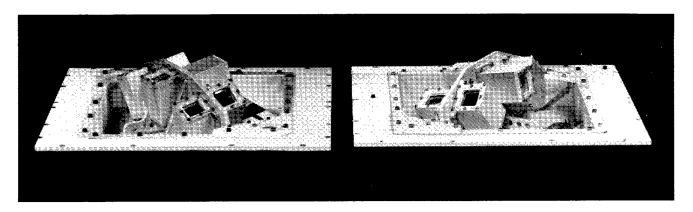
Figure 1. Side by Side Comparison of Wake Surface Paint Darkening (darker) and Ram Surface Paint Darkening (lighter).

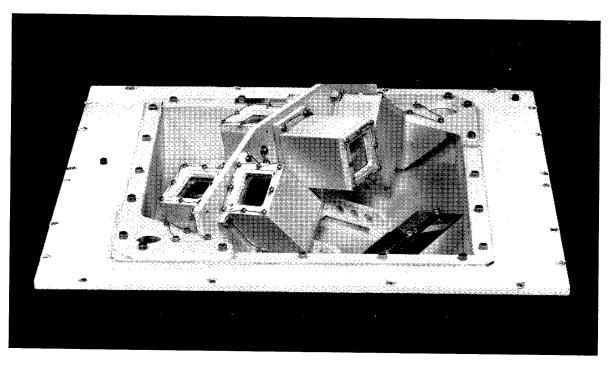
Figure 3. Variation of Darkening of the Same Paint on Different Coplanar Surfaces Exposed to Identical Darkening Agent Fluxes. Apparently, identical paint on identical surfaces will respond very differently, presumably due to different drying conditions or differences in paint preparation.

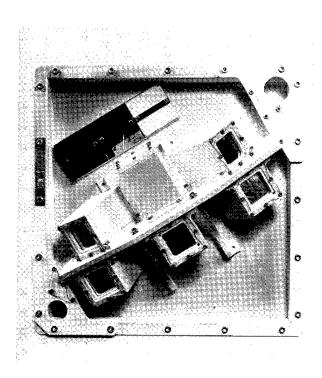
Figure 4. A View of the Variation of Paint Darkening Across a Surface on the Wake Side of LDEF.

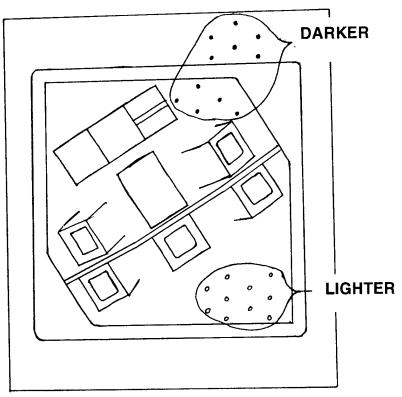
Figure 5. Note the Areas in Figure 4 Where the Outgassing Holes Have Reverse Video Rings.

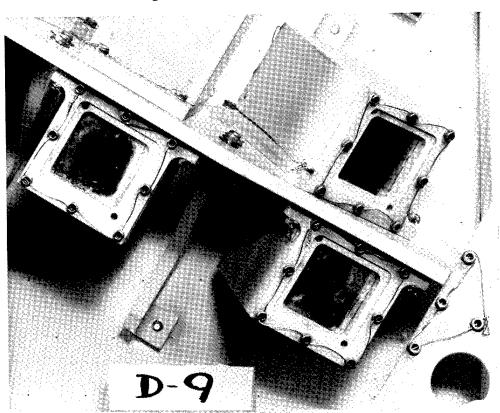
One top layer of track detectors, exposed to the space environment, was 0.023 inch thick (0.058 cm) CR39 polycarbonate which was manufactured by PPG Industries. After exposure to the ram oxygen flux it was severely etched. In the corners where the ram oxygen flux was enhanced by reflection from the painted aluminum surface, which was at a right angle to the CR39 surface, the etching was exactly the thickness of the CR39. At the corner the CR39 was burned all the way through along about half of the line formed by the corner. Far from the corner where there was no enhancement the CR39 was only partially burned.

These samples are being held in storage. As one can see from the figures, there were a number of samples, each with corners at differing angles with respect to the ram flux. Careful inspection of figure 6 will show three sample corners, one fully burned through, one partially burned through, and one not burned through. The samples are available for measurement if someone is interested in measuring the burn rate as a function of the angle of the two corner surfaces with

Figure 6. A Close View of the Enhanced Burning of CR39 Polycarbonate Near the Structural Corner Reflectors.

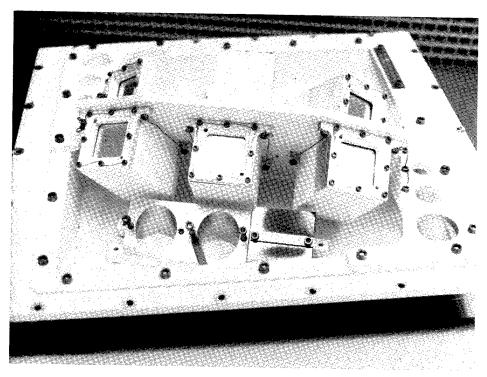
In figure 7, carefully inspect the dark brown region on the lower-right telescope, and note the white shadow to the right of the suspended wire. Somehow the wire cast a white shadow by preventing the paint from being colored brown. Based on references 2 and 3 we know that the sun angle varied over a wide range and could not have cast such a well defined shadow behind the wire. We measured the position of the shadow relative to the LDEF to help us determine the cause of the shadow.

Figure 7. A View of the Earth-end Materials Showing the Blue Oxide on the Silicon, and the Adjacent Brown Region with the White Shadow of the Wire. The brown region extends out of the earth face of LDEF into the ram flux and the rising sun ultraviolet.

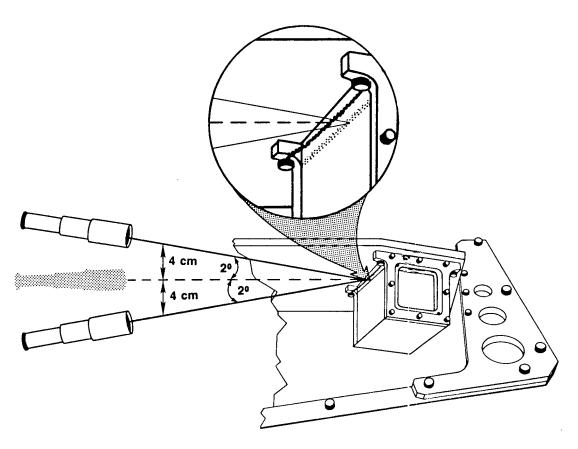
Figure 8 is a drawing of the measurement procedure. We sighted with a telescope from the ram direction. While remaining sighted on the wire and its shadow, we moved the telescope in the plane of the earth face of the LDEF. The shadow was found to be immediately behind the wire when the telescope was aimed exactly parallel to the line formed by the intersection of the plane, on which are mounted the six telescopes, with the earth face of LDEF. This line was constructed on LDEF to be at 14 degrees with respect to the surface normal of row 9 on LDEF. If the telescope was moved 2 degrees to either side, the shadow became visible behind the wire. Note that all previous reports of the ram direction indicate that the ram is at 8 to 10 degrees with respect to the surface normal of row 9. Why do we see a shadow at 14 degrees, and why is the shadow white, as if the white paint had not been colored behind the wire ??? If the ram flux were the cause of the shadow, then ram flux causes browning of the paint, AND, the ram flux is at 14 degrees, not 8 to 10 degrees. It is conceivable that at this telescope, the ram flow has become organized by interaction with the objects and subsequently flowed in a laminar fashion along the telescope mounting plane. Could it be possible that on row 9 of LDEF the ram flux bleached the uv browned paint, while on items protruding from the earth face the ram flux produced browning of the paint, not bleaching ?? How could one resolve this dilemma? We don't know.

Figure 8. Detail Drawing of the Analysis of the Shadow's Direction on the Ram Wall of the Structure Shown in Fig. 7. The central viewing angle is displaced from the normal to face 9 of LDEF by 14 degrees. The shadow was definitely within 2 degrees of this direction, and this direction is parallel to the inclined planar surface which holds the six proton "telescopes."

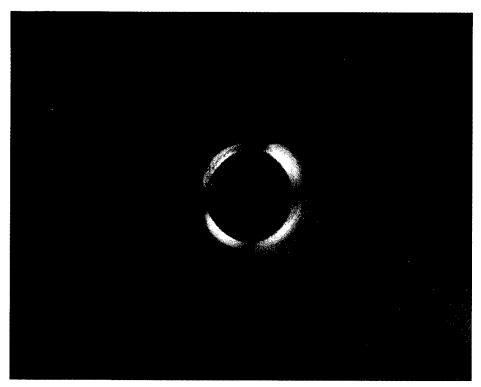
Photograph 4: Transmitted cross polarized light with a first order compensator plate was used to indicate the compressive stress frozen in the Teflon at this impact site. Transmitted illumination at a magnification approximately 300X. (Color version of black and white photograph on p. 872.)

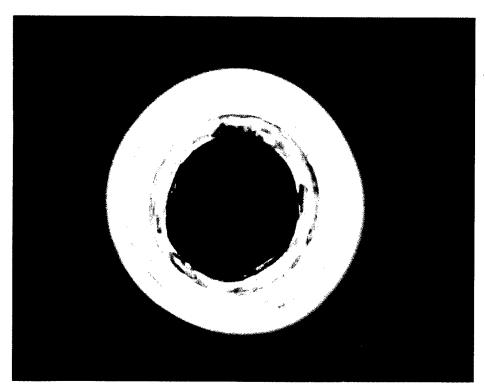
Photograph 5: Transmitted circular polarized light photograph of another impact site exhibiting very high residual stress. Transmitted illumination at a magnification approximately 125X.
